Manhole Inspection Summary

Manhole # S45K__032MH

Insp Date: **7/23/08 11:42 AM**

Location Address: **1919 Fleet St**

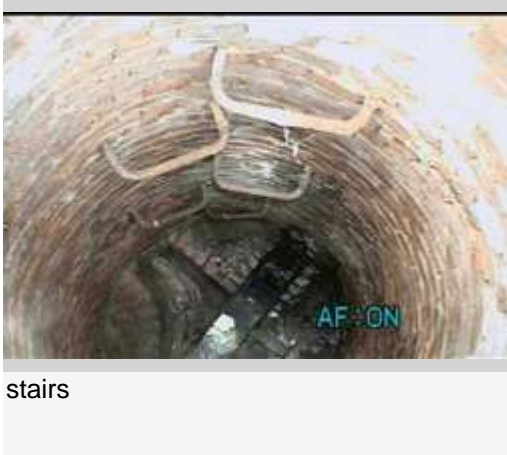
Defect 2

Count: **5** Missing: **0** ☒ **Corroded**

stairs

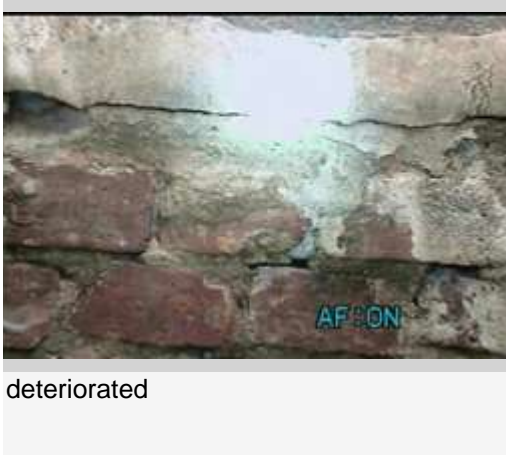
Defect 1

Condition: ☐ Sound ☐ Cracked ☐ Root Intrusion ☐ Loose Brick ☒ **Deteriorated**

deteriorated

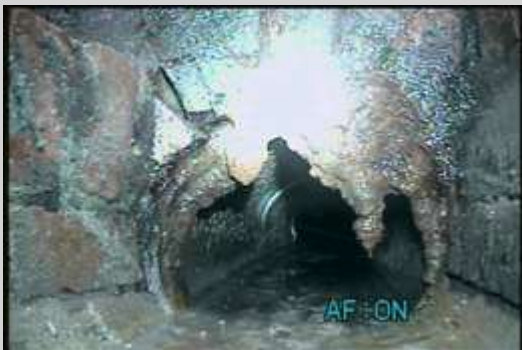
12 O'Clock Outflow

8 in. Circular Gravity Sewer
Pipe Out @ 12 O'Clock

Pipe Material: Clay ☐ Pipe Lined

Invert Depth: 10.11 (ft.) Flow Characteristics: Fast

Infiltration: None Pipe Seal Cond: Unknown

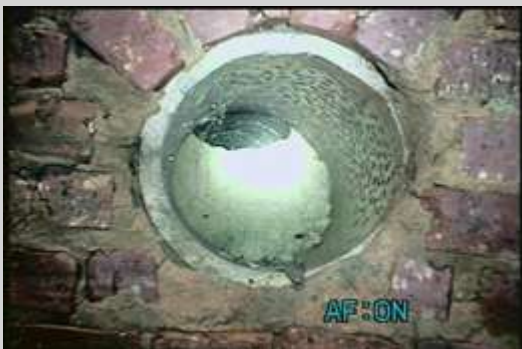
3 O'Clock Inflow

8 in. Circular Gravity Sewer
Pipe In @ 3 O'Clock

Pipe Material: Clay ☐ Pipe Lined

Invert Depth: 7.40 (ft.) Flow Characteristics: Fast

Infiltration: None Pipe Seal Cond: Unknown

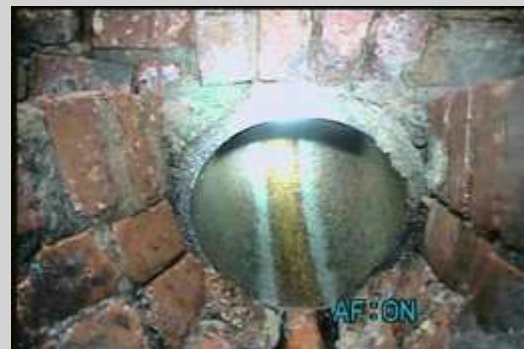
Drop In @ 3 O'Clock

Drop: Outside Direct

Inv Depth: 10.10 (ft.)

Drop Condition: Open

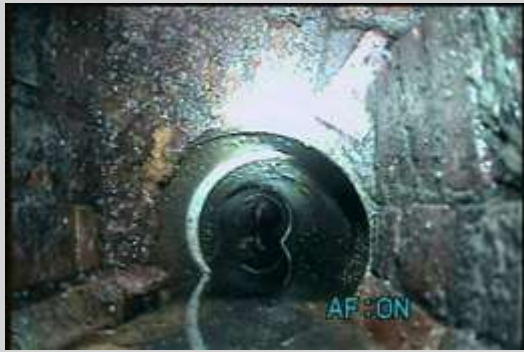
6 O'Clock Inflow

Pipe In @ 6 O'Clock

Pipe Material: **Clay** ☐ Pipe Lined

Invert Depth: **10.10** (ft.) Flow Characteristics: **Fast**

Infiltration: **None** Pipe Seal Cond: **Unknown**

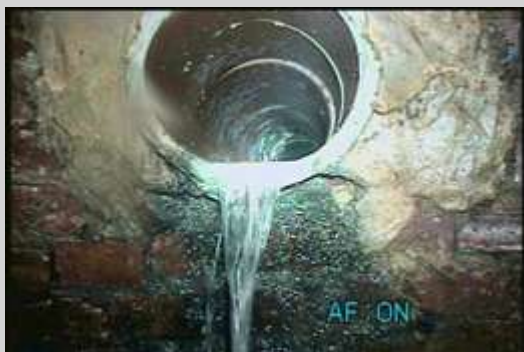
9 O'Clock Inflow

Pipe In @ 9 O'Clock

Pipe Material: **Clay** ☐ Pipe Lined

Invert Depth: **9.00** (ft.) Flow Characteristics: **Slow**

Infiltration: **None** Pipe Seal Cond: **Unknown**

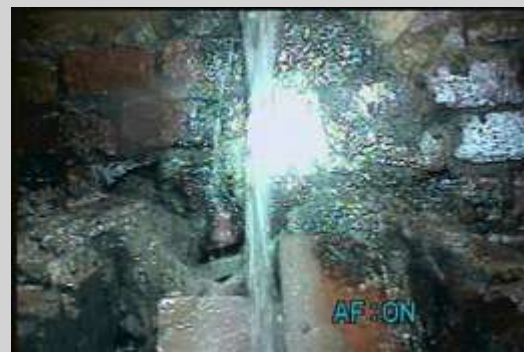
Drop In @ 9 O'Clock

channel debris

Drop: **Outside Direct**

Inv Depth: **10.90** (ft.)

Drop Condition: **Open**
